# Notifiable Tree Report

## Creswick V.I.C – Blue Atlas Cedar

(Author Matthew R. Daniel  
– Senior Arborist HSC)

(16<sup>th</sup> February 2026)

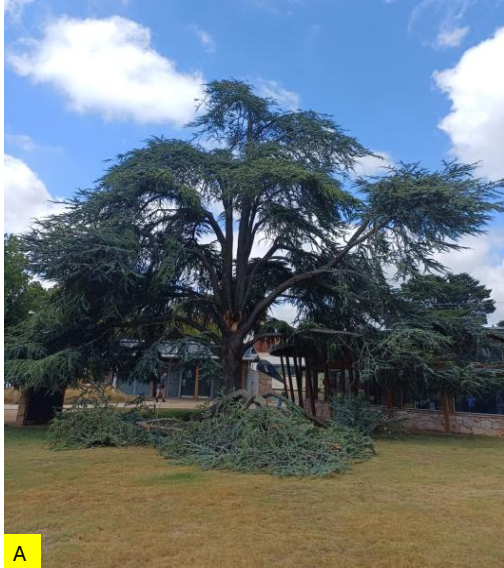
### 1.1 – Storm Damage – Leader failure

*Figure 1 – indicates the Cedar tree and branch leader in the foreground. The Co – dominant leader failure due to extreme weather event 9<sup>th</sup> February 2026*

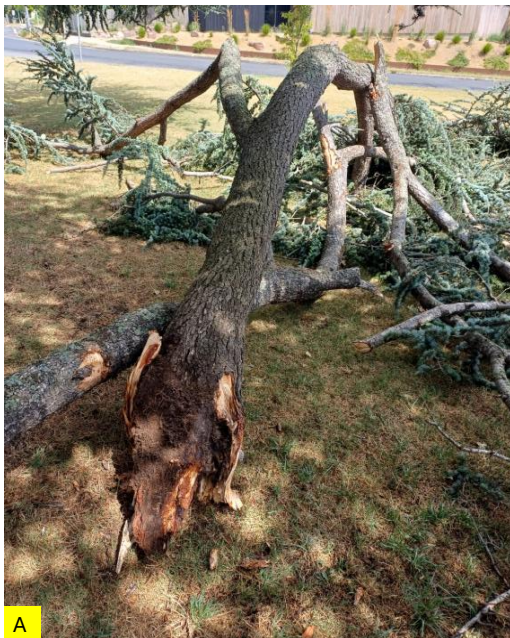
### 1.2 – Branch Leader on ground

*Figure 2 – indicates the branch leader on the ground*

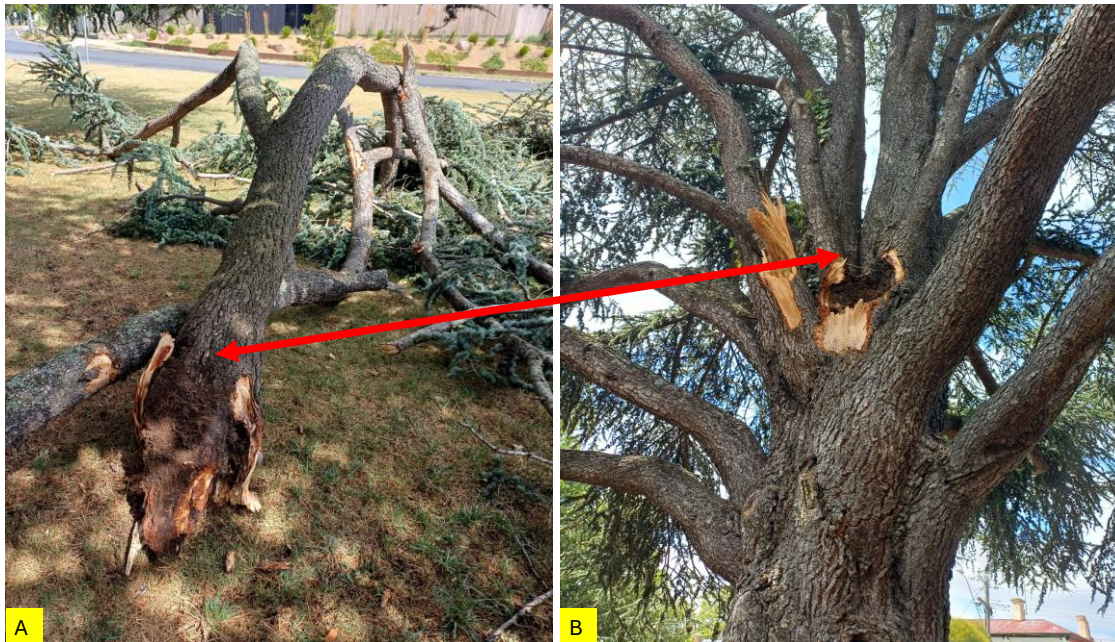
### 1.3 – Origin of branch leader

The bark inclusion has allowed the accumulation of organic matter and moisture within the unions (refer Figures 3–5). Over time, this has led to soil development and decay progression between the leaders, with visual indications of a **potential decay pocket** forming below the codominant union at the point of attachment to the main stem. The presence and extent of internal decay could be further confirmed through **sonic tomography**, a non-invasive diagnostic technology that utilises sound waves to produce detailed images of a tree's internal structure.

Figure 3 – A. indicates the union and branch collar with B. indicating the origin of the failed branch collar.

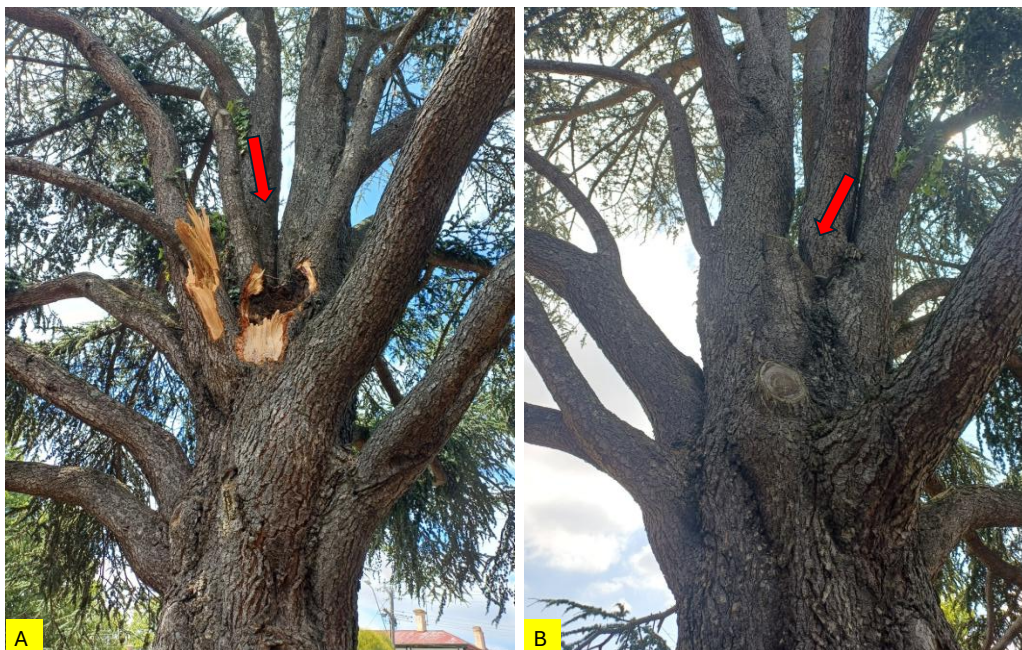
### 1.4 – North and south side of canopy

Figure 4 - A. indicates the North side of the tree where the tear out occurred, with the visible failed union and broken branch. Red arrow indicates the remaining co – dominant leaders and where the bark inclusion is located B. indicates the South side of the tree (Adjacent to path to facility) with bark inclusion between retained co – dominant leaders.

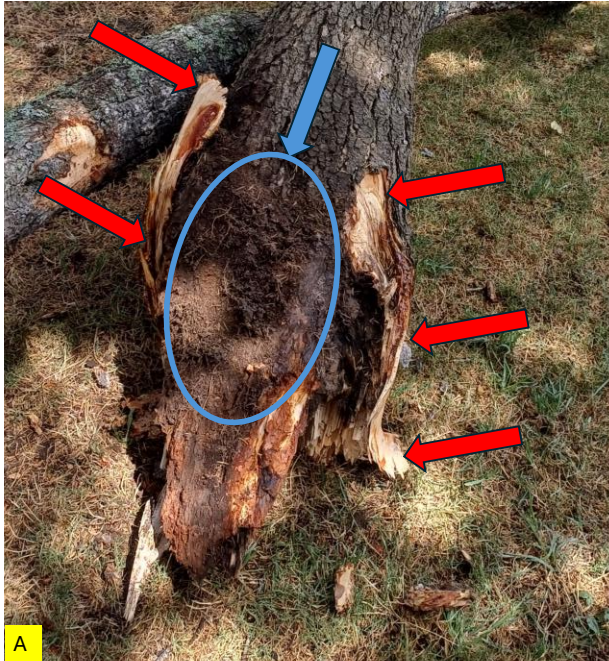
### 1.5 – Bark Inclusion tear out close up

Figure 5 – Indicates the branch leader collar. Red arrows indicate the narrow holding wood (Light colour) that was attaching the branch to the other co-dominant leaders. The blue arrow and circle indicate the bark inclusion area. Canopy Roots can be seen growing in debris forming humic material collecting in the union and holding moisture in the area. This part of the union was not attached to the other co-dominant leaders. This is the causative factor of the failure. The bark inclusion reduced the structural integrity and the damaging wind gusts provided the forces required to make the union fail.
