## **Arboricultural Report**

Address: 41/43 Albert Street Creswick, Victoria 3363

**On Behalf of  
Hepburn Shire Council**

17/4/2026

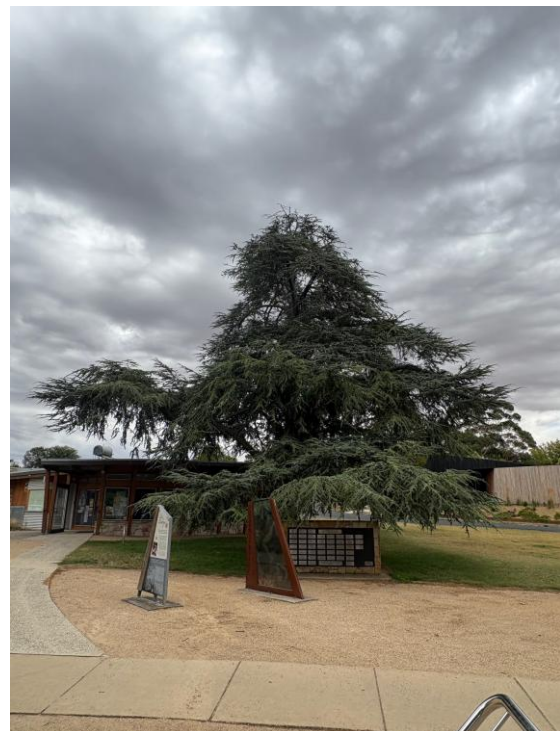
| <b>Tree 1</b> | |

| <b>Defects</b> | Signs of previous failures, extended limbs in canopy. Signs of possible decay in main union, multiple stems with acute angles of attachment. Ivy growing from main union. |

During a weather event in February 2026 the tree lost a significant limb on the north side of the canopy. This is not the first time the tree has lost a limb, there is a wound of the south side of the crown from a previous failure. The recent failure at the union of codominant stems confirms the presence of deeply included bark. This structural defect prevents the development of a branch bark ridge, resulting in a weak connection that is unable to support the weight of the limbs during dynamic wind loading. The presence of adventitious (aerial) roots at the failure site is a possible indicator of decay in the union. These roots typically develop in response to moisture and decomposing wood within a compromised union.

Having taken into consideration the tree, location, previous failure and remedial options it is recommended removal of the tree and replanting with a species selected by Hepburn Shire.
